Primary Name	Location Address	City	County	Postal Code
DALTON CORPORATION WARSAW MANUFACTURING FACILITY	1900 E JEFFERSON ST	WARSAW	KOSCIUSKO	46580

Re: Violation Letter  
Dalton Corporation/Warsaw  
IND 005 146-022  
Warsaw, Kosciusko County

Type of Inspection:	<u>X</u>	Compliance Evaluation Inspection
	<u>    </u>	Complaint
	<u>X</u>	Other: <u>Restricted Waste Site Inspection</u>
Results of Inspection:	<u>    </u>	No violations were observed
	<u>    </u>	Additional information and review is required to evaluate overall compliance.
	<u>X</u>	Violations were observed and will be referred to the Office of Enforcement. See inspection report.

The restricted waste site is permitted as a Type II landfill for the disposal of wastes generated by Dalton's foundry operations. The total acreage of the facility is 156 acres with 68.4 acres permitted as a Type II landfill. The facility is currently filling in all three Phases and has not minimized the working face of the landfill. Intermediate cover has only been applied to the western edge of Phase 1 and the southern edge of Phase 2. There are many areas that have not received waste within one year and have not received intermediate cover. Cu

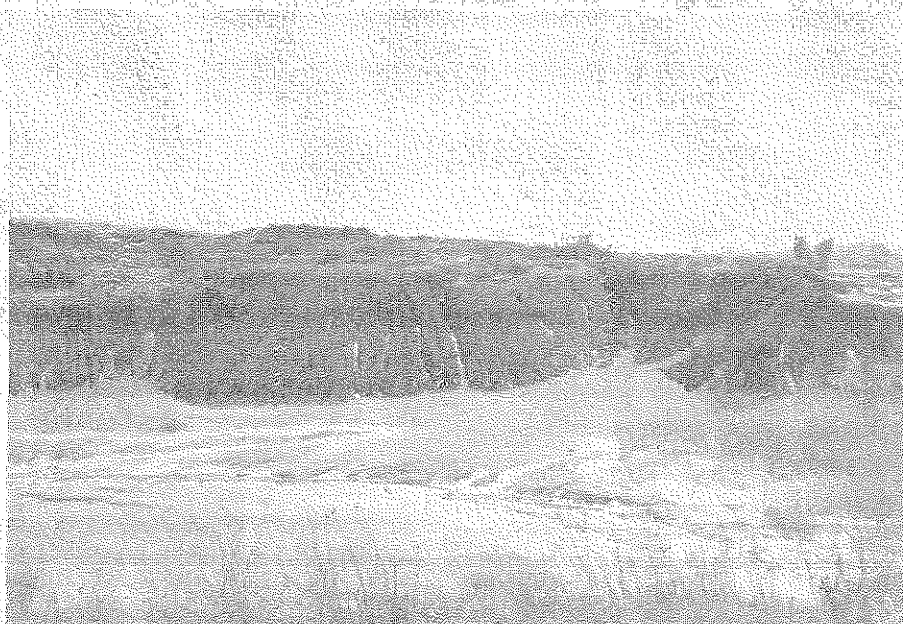
Photo 9

**Location and Subject:** Field north of Phase 1 - Outfall at State Road 25 receiving runoff from the drainage ditch north of Phase 1.

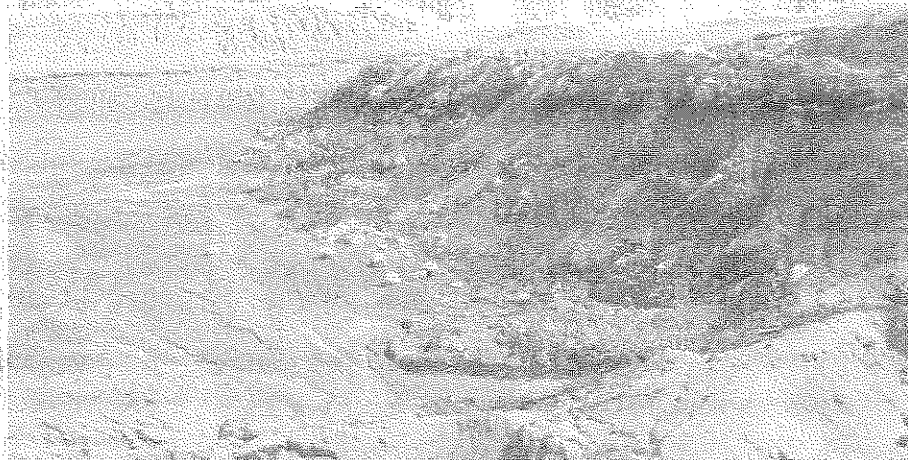
**Photo 12**

**Location and Subject:** Working face of Phase 3, Section 1 -- Large area of exposed working face promoting erosion by surface water and allowing surface water to contact the waste. The leachate from the bottom of this fill area discharges to a drainage ditch located in the northeast corner of the cell and eventually into a wetland area and Boggs Ditch.

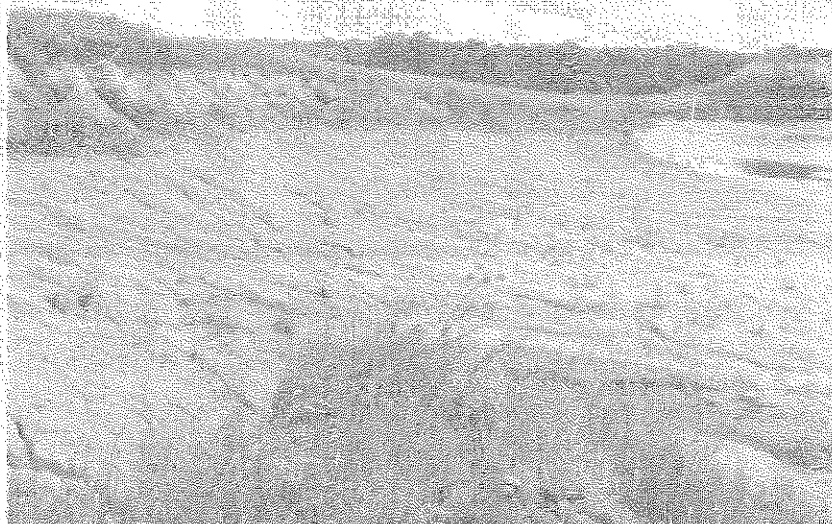
**Photo 2**

**Location and Subject:** West side of Phase 3, Section 1, facing east - Erosion of buried waste caused by surface water runoff from the top of the fill area and migrating into the bottom of the fill area.

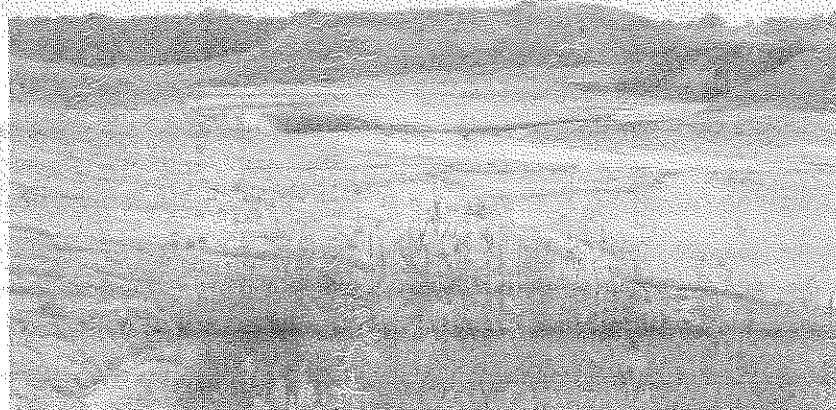
**Photo 3**

**Location and Subject:** West side of Phase 3, Section 1, facing east - Erosion of the clay side walls along the northern side of the fill area.

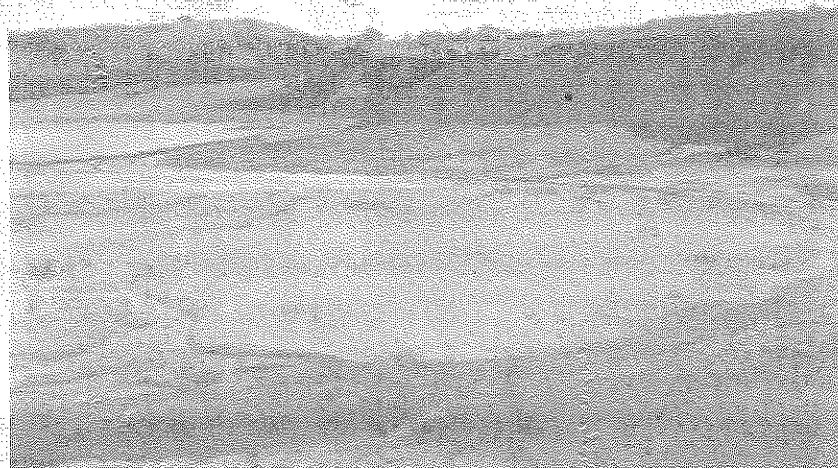
**Photo 4**

**Location and Subject:** West side of Phase 3, Section 1, facing east - Erosion of the buried waste and clay side walls along the northern side of the fill area migrating into the bottom of the fill area.

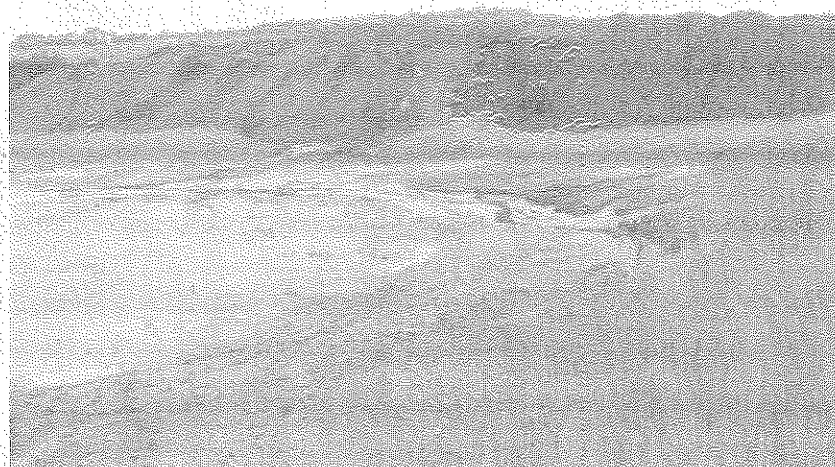
**Photo 5**

**Location and Subject:** West side of Phase 3, Section 1, facing east – Erosion of the buried waste and waste coming into contact with surface water/leachate.

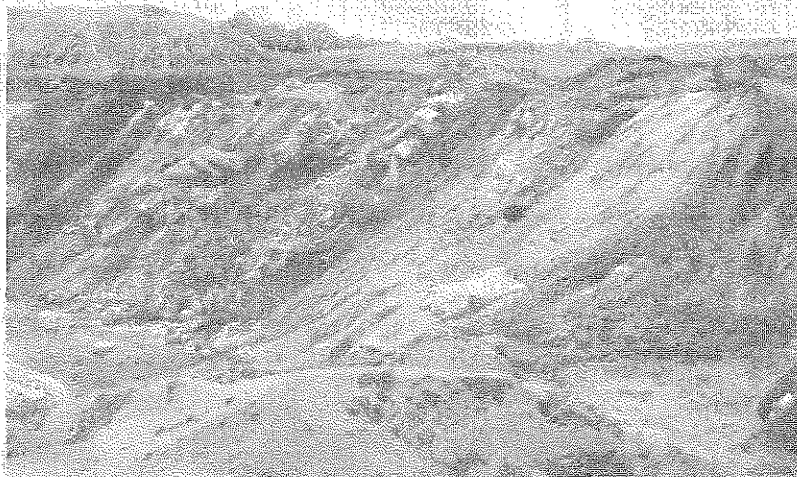
**Photo 6**

**Location and Subject:** West side of Phase 3, Section 1, facing southeast – Erosion of the buried waste migrating into the bottom of the fill area.

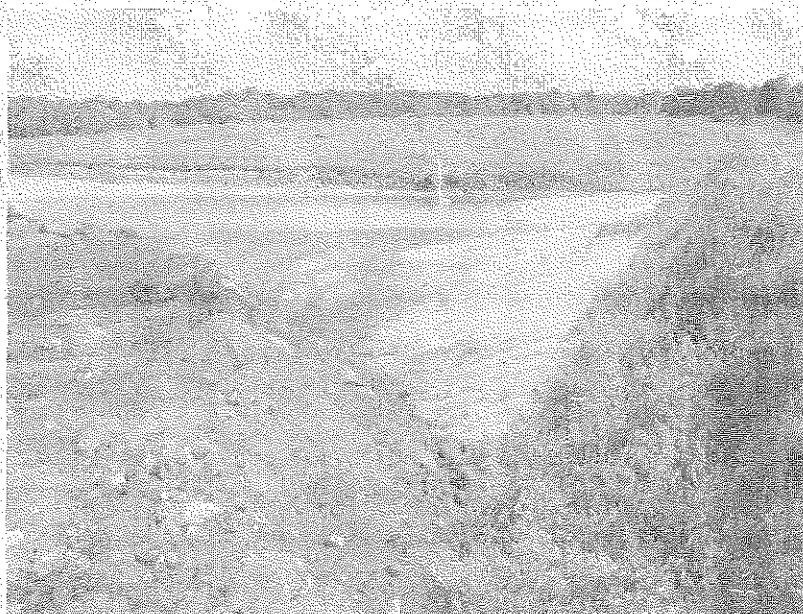
**Photo 10**

**Location and Subject:** South side of Phase 3, Section 1, facing east -- Piles of yard clean up.

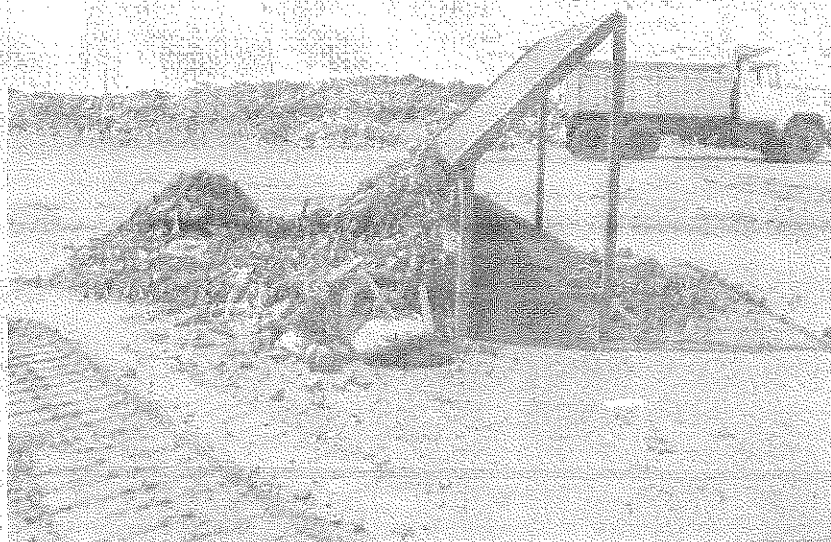
**Photo 11**

**Location and Subject:** Southeast side of Phase 3, Section 1, facing north – Working face of the fill area extending past the clay liner. The leachate collection sump is located in the background.

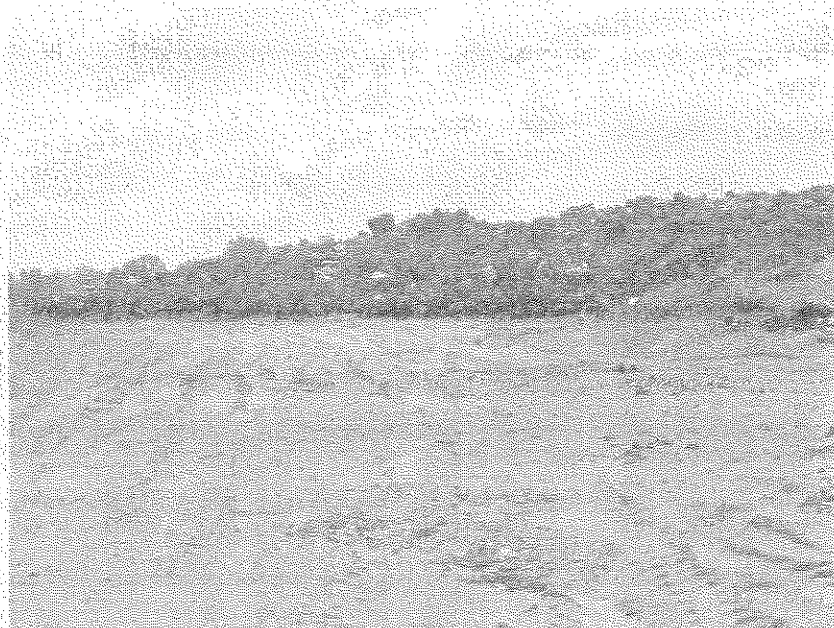
**Photo 13**

**Location and Subject:** West side of Phase 3, near Phase 2 border -- Metal salvaging materials stored on the ground.

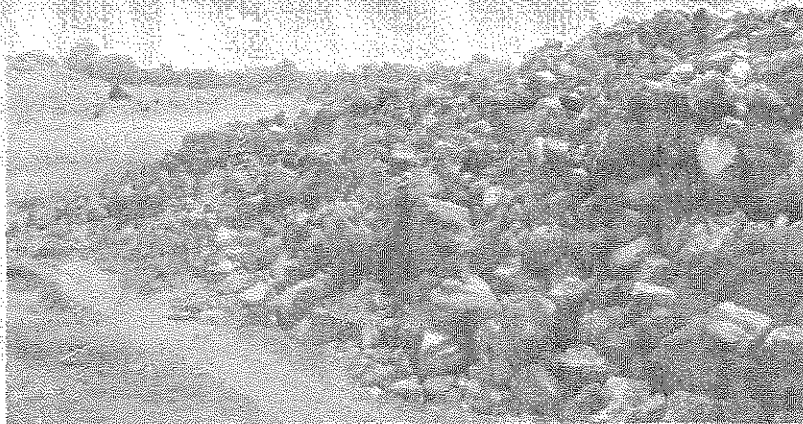
**Photo 14**

**Location and Subject:** Phase 2.-- Large pile of slag deposited near the border of Phase 2 and Phase 3. The slag pile is approximately 250 yards by 100 yards and ranging from 5 to 15 feet in height.

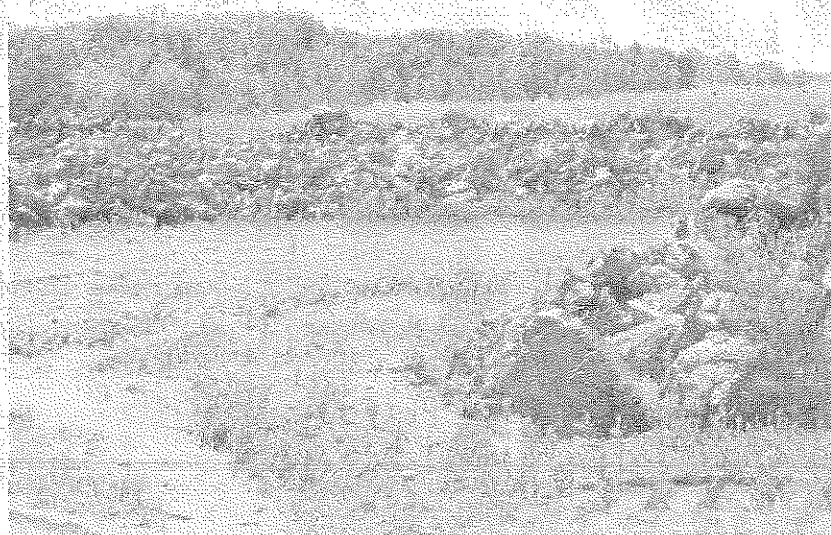
**Photo 15**

**Location and Subject:** Phase 2 - Large pile of slag deposited near the border of Phase 2 and Phase 3 exceeding the height limit.

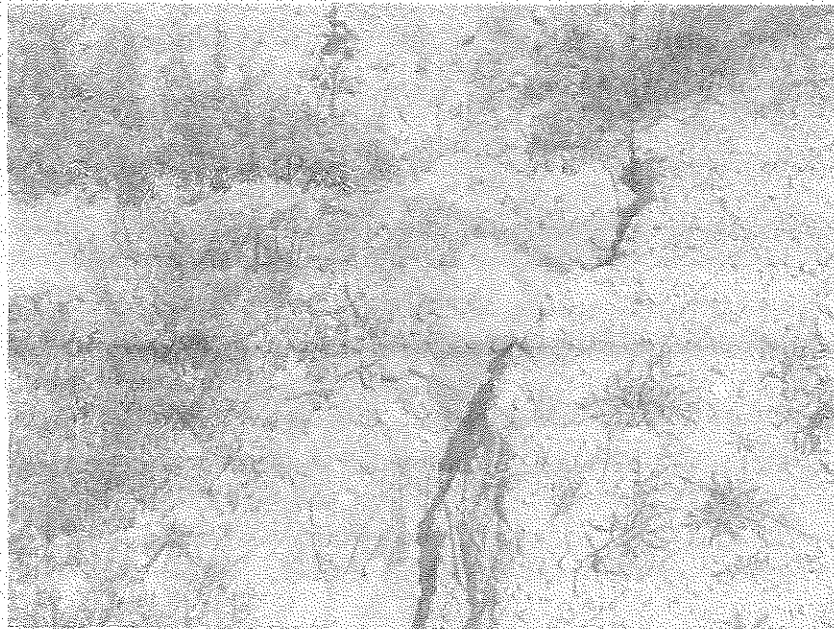
**Photo 25**

**Location and Subject:** East side of Phase 2 – Erosion cut through the cap exposing the buried waste.

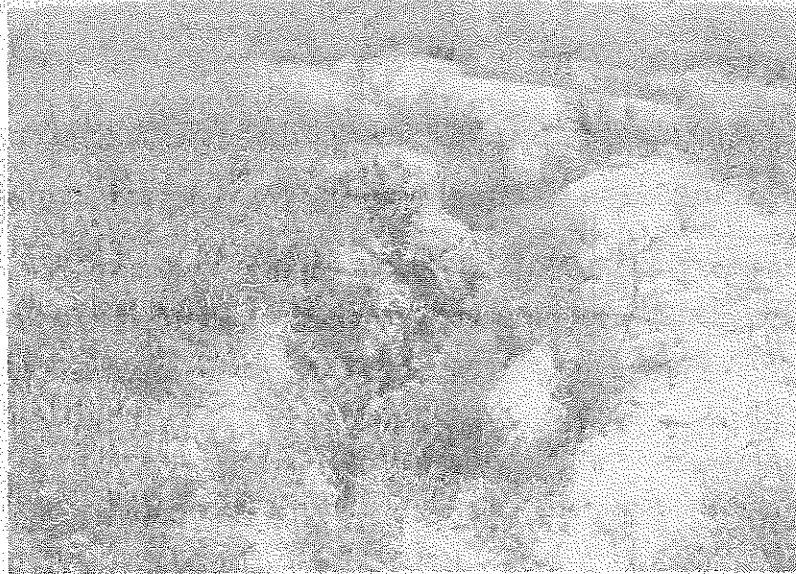
**Photo 26**

**Location and Subject:** East side of Phase 2 – Erosion cut through the cap exposing the liner.

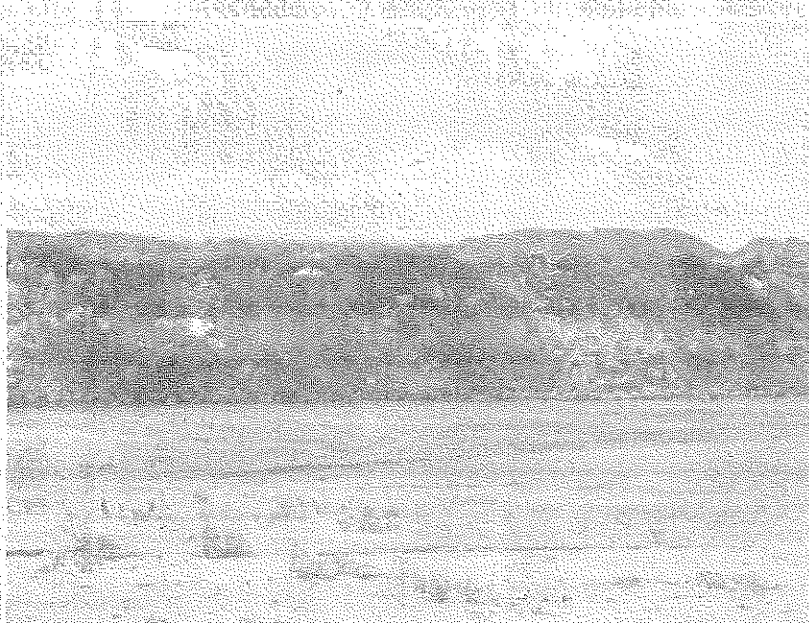
**Photo 39**

**Location and Subject:** Northeast side of Phase 3, Section 1, facing south -- Active fill area.

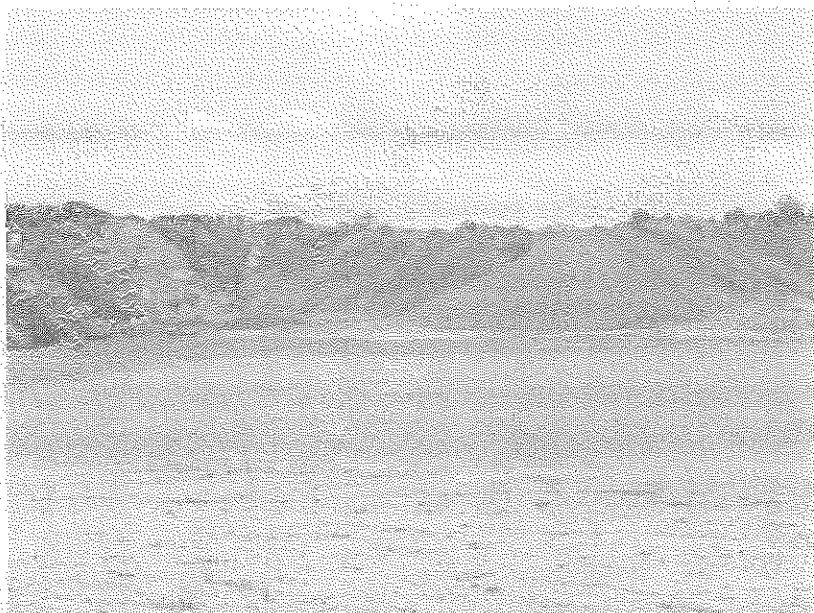
**Photo 40**

**Location and Subject:** Northeast side of Phase 3, Section 1, facing southwest -- Working face and leachate in the bottom of the fill area.

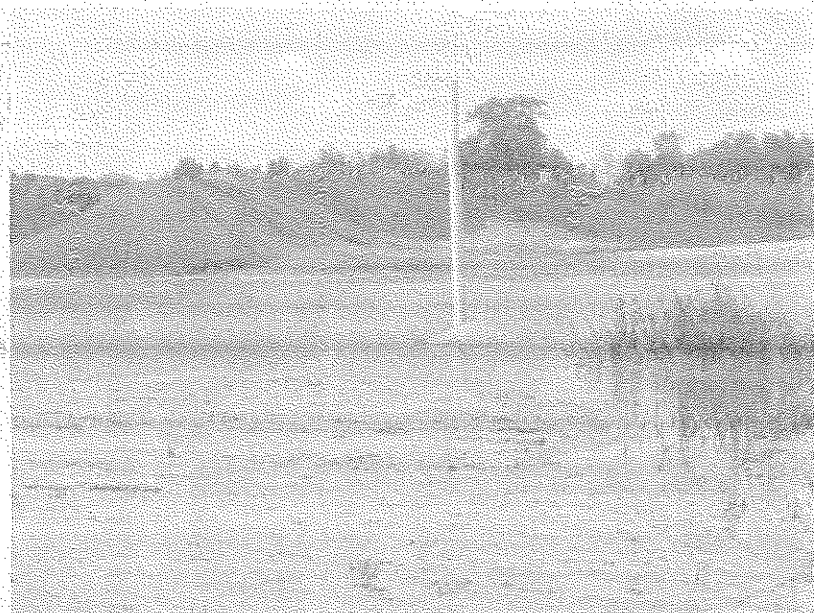
**Photo 41**

**Location and Subject:** Northeast side of Phase 3, Section 1, facing southwest – Working face and leachate in the bottom of the fill area.

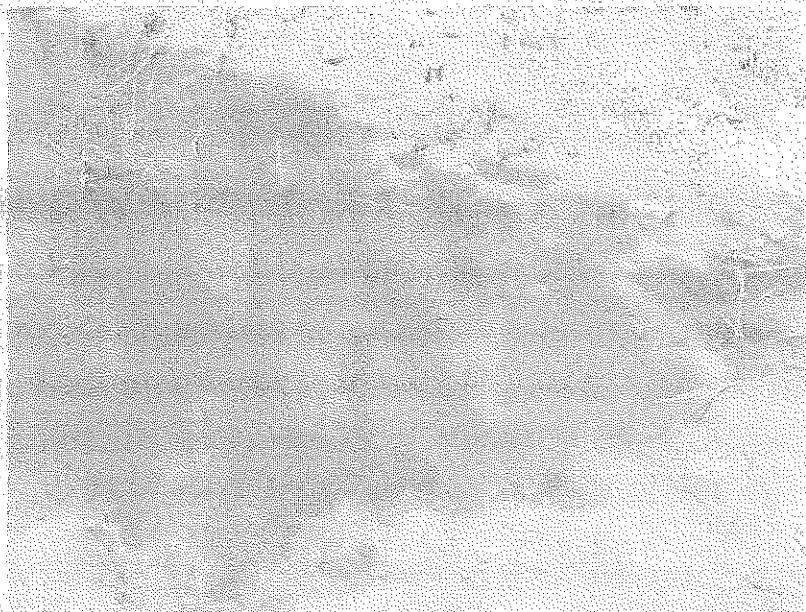
**Photo 42**

**Location and Subject:** Northeast side of Phase 3, Section 1, facing southwest – Leachate collection sump not being utilized by the facility to collect and control leachate from migrating off-site.

Leachate collection systems must be operated in such a manner as to comply with the design standards and plans specified in 329 IAC 10-26-1(b). The permittee shall install a leachate collection sump in the northeast corner of Section 1 of Phase 3. The location is depicted on plan sheet Figure 3 titled "Proposed Base Grade Elevation for Section 1 of Phase III, Alternate Site Monofill (Revised)," dated September 23, 2005. The permittee shall remove and properly dispose of leachate from the sump whenever a pumpable volume of leachate exists in the sump.

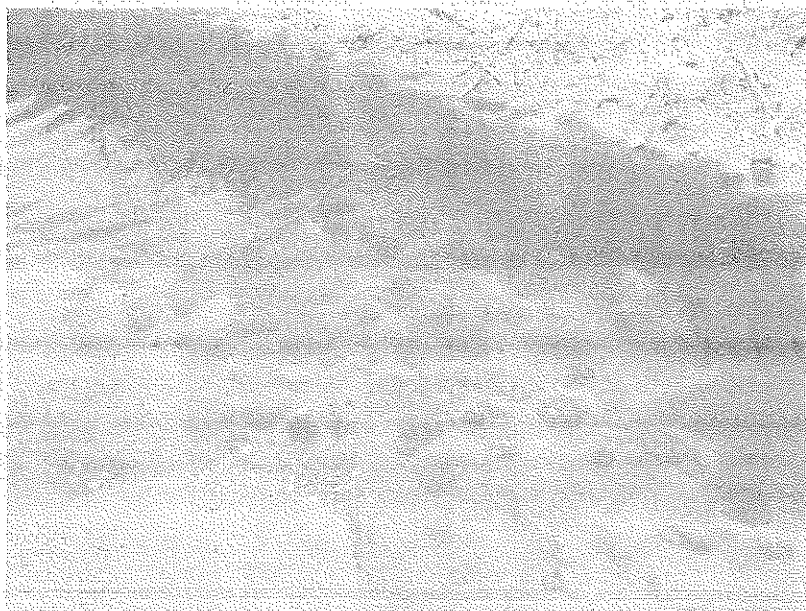
**Photo 43**

**Location and Subject:** Northeast side of Phase 3, Section 1 - Close up of leachate discharging to the drainage ditch and into the wetland area and Boggs Ditch to the north
